Reference: Plate 2 based on Touchstone Development's
07/97 Plate 2, Boring and Monitoring Well Locations

EDD CLARK & ASSOCIATES, INC.
ENVIRONMENTAL CONSULTANTS

SITE MAP,
23 July 2002 Groundwater Analyses
2800 Corby Avenue
Santa Rosa, California

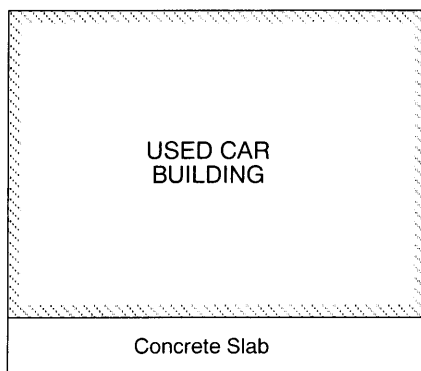
2

- ▲ **B-1** Soil Boring (Mar-May 90)
- **P-1** Soil Boring (Oct 97)
- ⊙ Monitoring Well (Mar-May 90)
- ⊙ Monitoring Well (Jul 00)
- (190/290/ND/ND) Concentrations of TPHg/TPHd/MTBE/Benzene in Groundwater in µg/l:
Reporting Limits = (50 / 50 / 0.5 / 0.05) µg/l
- NS; ND Not Sampled; Not Detected above Reporting Limits
